1 **Reuse of Existing Steel Pile Foundations – Greenock**

2 **Creek Bridge, Walkerton, Ontario, Canada**

10 **Abstract**

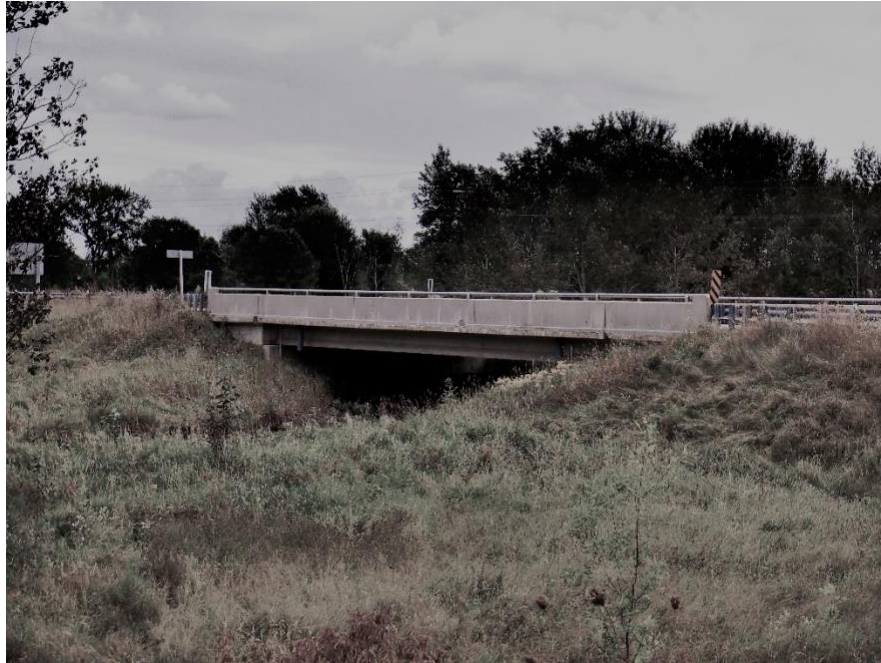
Figure 1 – Photograph of Greenock Creek Bridge

93 A photograph of the bridge site is presented in Figure 1.

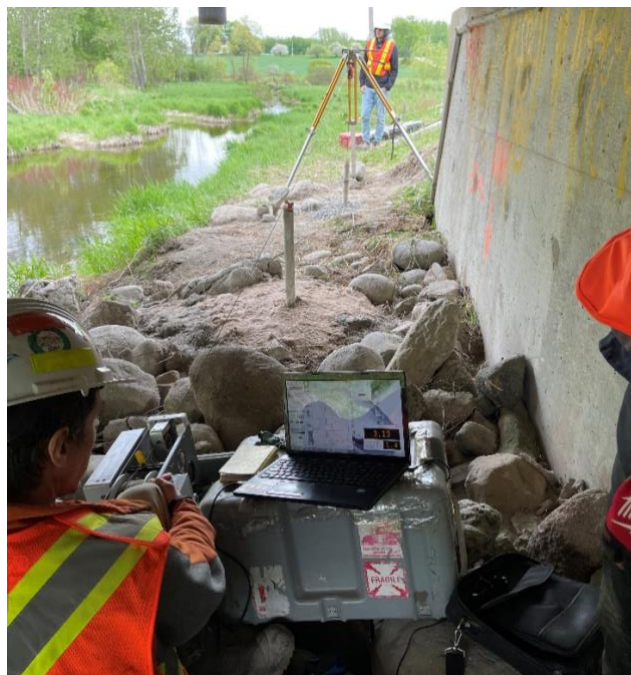
128 A photograph of the geophysical test set up is shown in Figure 3.

Figure 3 – Geophysical Testing in progress

- 124 • Parallel Seismic Test as per ASTM D8381/D8381M-21
- 125 • Borehole Magnetometer Test as per ASTM D6726-01
- 126 • Electromagnetic Test as per ASTM D6726-01
- 127 • Natural Gamma Test as per ASTM D6274-18

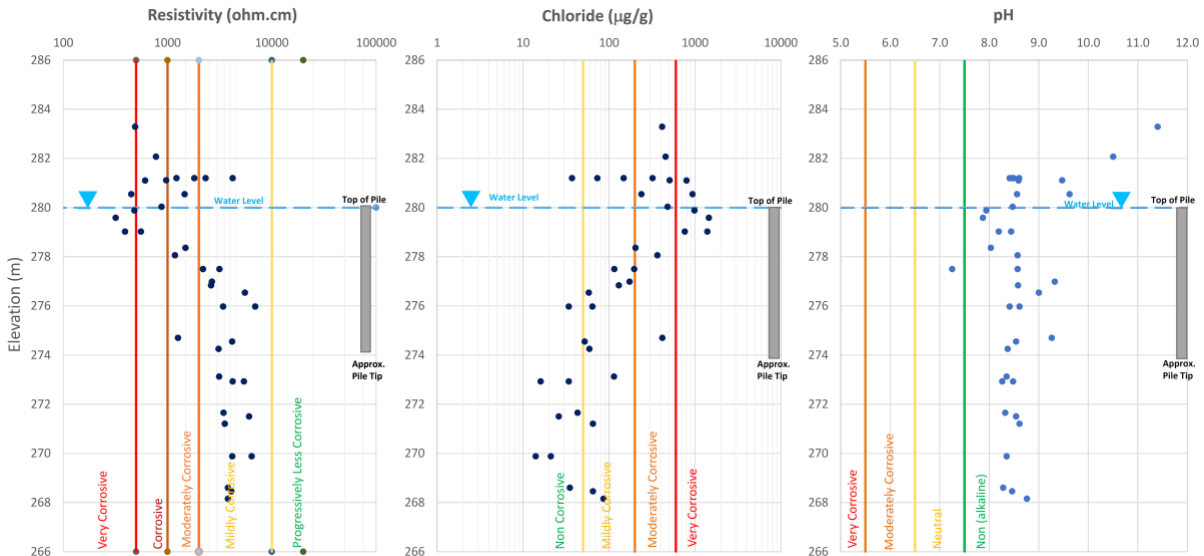
149 The results of the corrosivity tests are summarized on Figure 5, which also schematically
 150 shows the relative location of the existing piles. The results were compared to the

155 Figure 5 – Corrosivity Test Result Summary

163 The following conclusion may be drawn from Figure 5:

- 164
- The upper 3 to 4 m thick approach embankment fills are generally corrosive to
- 165 steel piles mainly due to low resistivity and high chloride content. This is largely
- 166 the result of road salting operations over the years.

- 167 • The soils surrounding the upper 1 m of the piles are corrosive in nature due to low
168 resistivity and high chloride content.
- 169 • Below 1 m from the top of the piles, the resistivity and chloride content indicate a
170 mildly corrosive soil environment.
- 171 • The groundwater tested indicates a moderately corrosive environment.
- 172 • pH content of the soils/groundwater tested indicates a non-corrosive (alkaline) and
173 neutral environment.
- 174 • The top of the piles is at the water level. The piles are in submerged condition.
- 175

226 The corrosivity test results reported in Figure 5 indicated that the upper 1 m of the piles
227 are located in a corrosive soil and groundwater environment. The remaining pile is
228 embedded in mildly corrosive environment. Corrosion of steel piles is more likely to occur
229 when they are exposed to corrosive soil and groundwater as well as the presence of
230 moisture and oxygen. Deeper soils have no access to oxygen, resulting in low corrosion
231 potential.

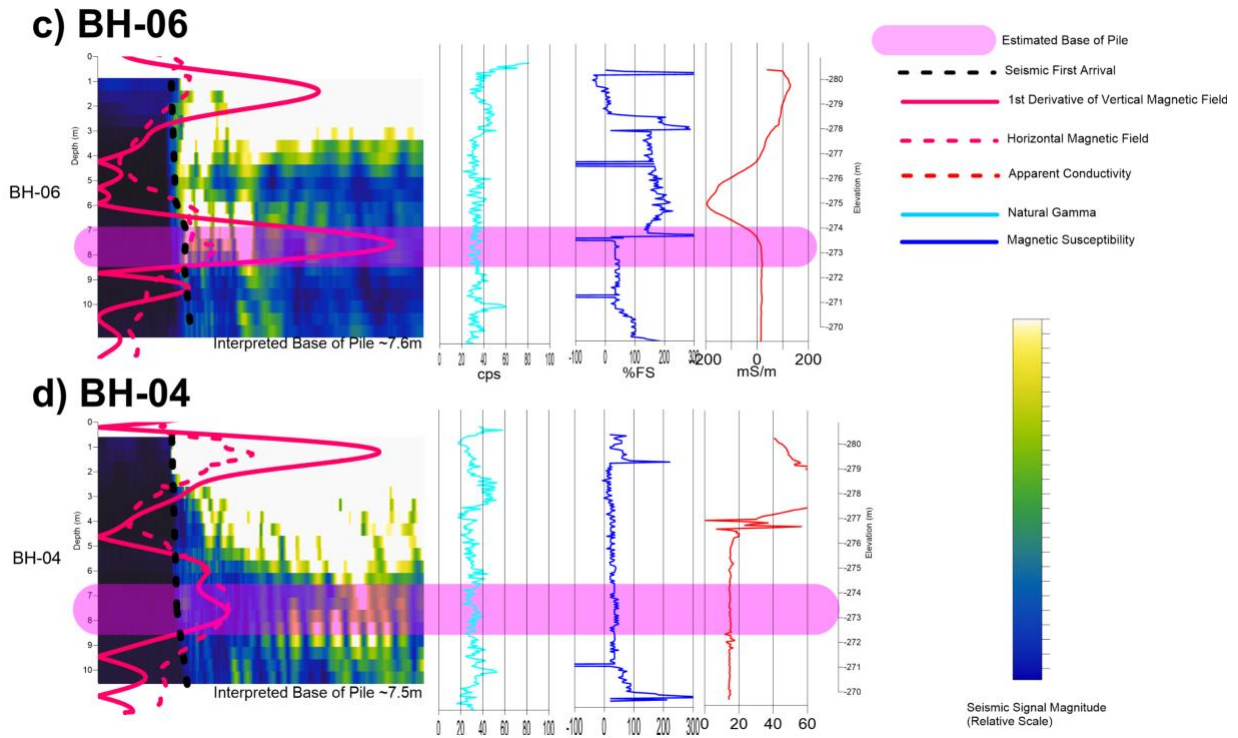
195 An example of downhole geophysical test results are presented in Figure 6 at the east
196 abutment of the bridge. The figure shows the estimated base of pile depths based on the
197 results of the Seismic First Arrival Time, First Derivative of Vertical Magnetic Field,
198 Horizontal Magnetic Field, Apparent Conductivity, Natural Gamma and Magnetic
199 Susceptibility. The magnetic field values (both horizontal and the gradient of the vertical
200 components) for the boreholes show two anomalous zones, one extending from the
201 surface to about 3 m depth, and another centred about 7 m depth. The lower of these two
202 anomalies likely represent the approximate bases of the piles. The gradient of the vertical
203 component showed much clearer peaks than the horizontal component, suggesting that
204 the vertical derivative may be able to delineate the pile extent with greater precision.

206 Figure 6 – Geophysical Test Results Indicating Estimated Pile Depth at East Abutment

207 The estimated pile lengths based on the geophysical testing is listed below:

208 West Abutment estimated battered pile length: 6.3 to 6.5 m

209 East Abutment estimated battered pile length: 7.1 to 7.2 m

210 The design pile length was 7.9 m. Out of the four geophysical methods attempted, the

211 Parallel Seismic and Borehole Magnetometer methods appear to give the clearest
