RISKS ASSOCIATED WITH REUSE AND REMEDIATION OF FOUNDATIONS

Pawan Sethi, Tetra Tech Coffey, The University of Sydney, Sydney, NSW, Australia, +61294061011, pawan.sethi@tetrattech.com, pawan.sethi@sydney.edu.au

- 1) The Honourable Artillery Company (HAC) – Extension of the Albert Room – London, UK
- 2) ICD Brookfield Place Tower – FIDC, Dubai, UAE

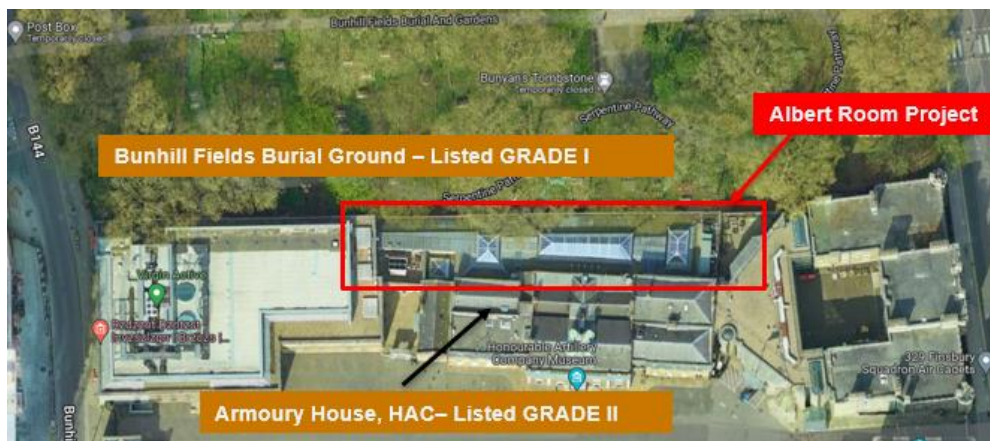
Fig. 1. Location of Albert Room and Bunhill Fields Cemetery

The northern boundary of the Armoury House abuts the grade I heritage listed Bunhill Fields burial ground. Bunhill Fields (Fig. 1) first started being used as a dedicated burial ground in 1665 and this continued until about 1854. The Bunhill Fields cemetery is the resting place of a number of famous personalities, including John Bunyan, Daniel Defoe and William Blake amongst others, and no disturbance of the ground was permitted.

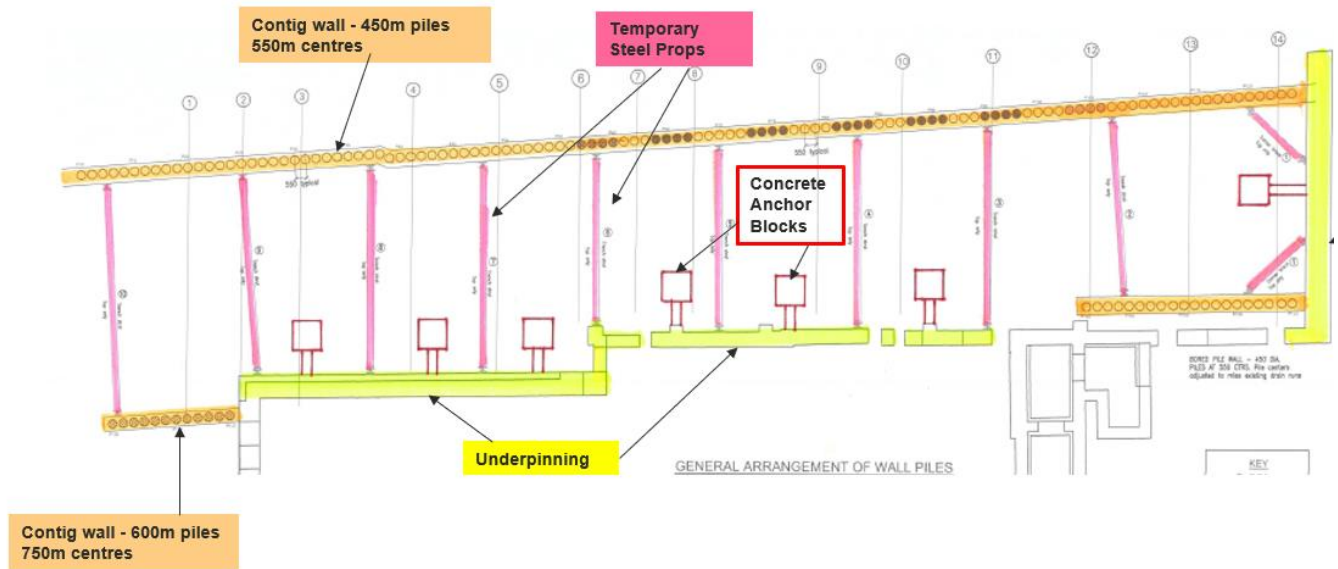
Fig. 3. Plan showing the adopted design solution.

The solution for the northern wall, which was adjacent to the burial ground, consisted of 135, 450 mm diameter piles at 550 mm centres, where the ground retention and existing footing support were the primary requirements. The pile lengths ranged between 8 m and 12.5 m. Larger 600 mm diameter piles at 750 mm centres were used to support new columns and there were nine of these piles in total. Some 450 mm diameter piles were also used at the southern end – refer to Fig. 3.

The mitigating measures against potential rotation of the underpinned southern wall and a portion of the eastern wall included construction of mass concrete anchor blocks connected with ground beams, which extended to the base of the underpinned walls – see Figs. 2 and 3.

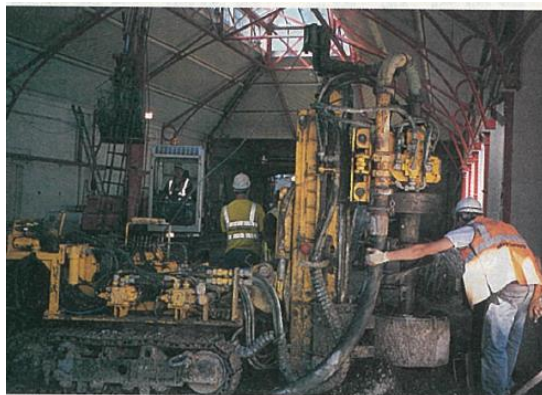
Fig. 4. CFA rig in low headroom mode

In order to reduce the risk of bore instability during pile drilling and reduce excessive vibrations, the continuous flight auger (CFA) piling technique was adopted. A low headroom piling rig was used to maintain clearance to the heritage roof, see Fig. 4. Figure 5 shows a piled wall installed with temporary props in place. Areas on either side of the existing Albert Room had a greater headroom of 15 m, and consequently, it was possible to use a different rig (14.9 m height) to install piles. The CFA rig was able to drill through gravels and careful execution of works ensured that there were no adverse impact on the heritage elements.

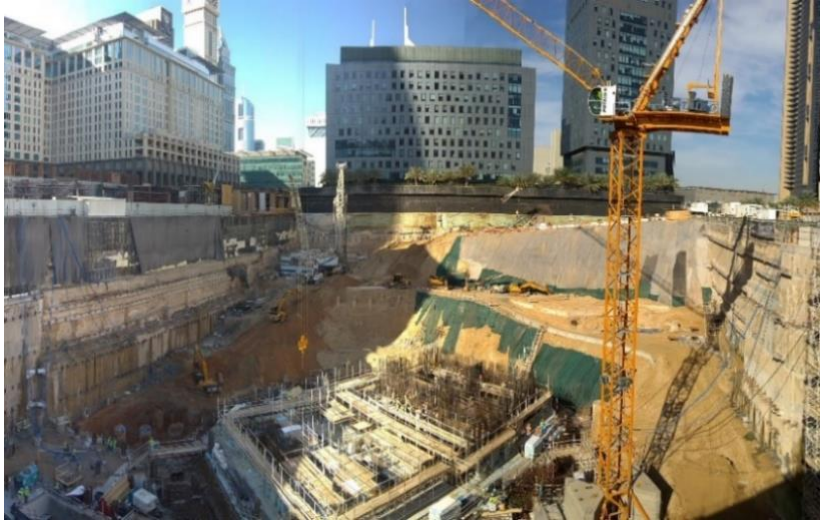
Fig. 12. The new tower under construction

The concrete compressive strengths and reinforcement tensile strengths were found to be well in excess of 60MPa and 550MPa, respectively. The two maintained load tests performed satisfactorily under the working and test loads. The load versus vertical settlement curve indicated a relatively stiff behaviour, which provided the confidence and assurance for reusing the existing piles. Figure 12 shows the tower under construction and Figure 13 shows the completed ICD Brookfield Place Tower.
