THE INSPECTION AND TESTING OF EXISTING FOUNDATIONS TO ASSESS THEIR SUITABILITY FOR REUSE AND EXTENDED USE, NATIONAL STATE OF PRACTICE IN THE NETHERLANDS

M.J. Profittlich MSc, Fugro, Leidschendam, Netherlands, +31622934237, m.profittlich@fugro.com.
F. van Lier, KCAF, Nieuwegein, Netherlands, +31653107333, f.vanlier@kcaf.nl.

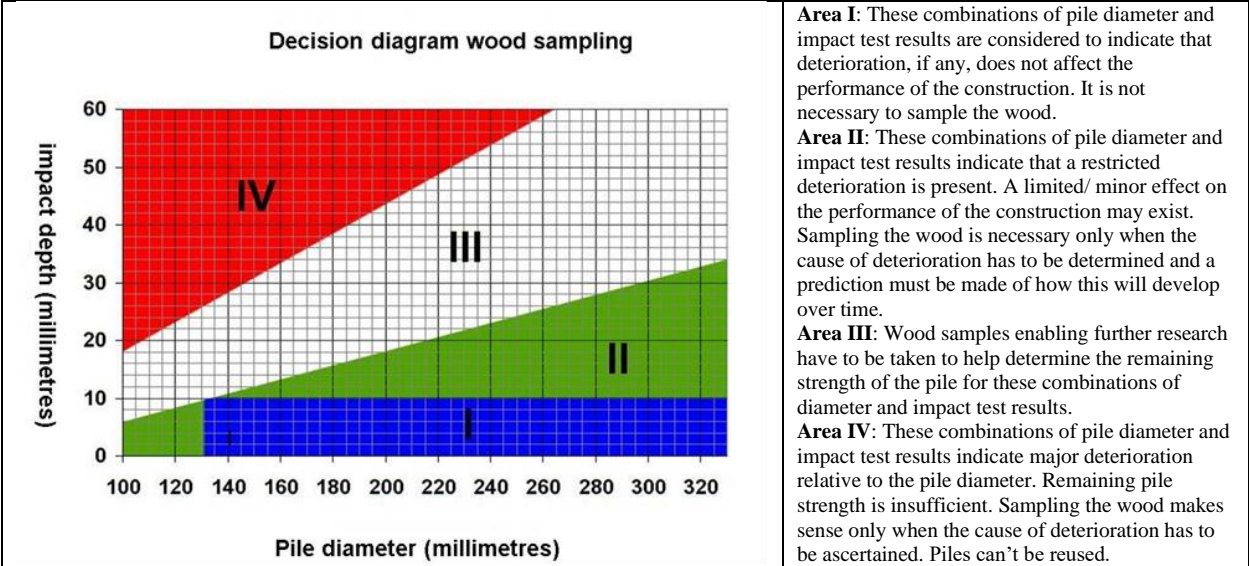
Fig. 4. Decision diagram of wood sampling (F30/KCAF).

It is also recommended to measure the thickness of the soft shell of the timber piles and wooden elements. This measurement can be executed by a (small) impact hammer. The results of this measurement will inform us the rate of degradation and which parts can't contribute to specific bearing capacity. Part of the foundation inspection can be wood sampling according to figure 4. The necessity is dependent on the pile diameter and thickness of the soft shell of the timber piles. This figure is not applicable for concrete or steel pipe piles.
