TESTING AND REINFORCING OF EXISTING FOUNDATIONS FOR CONVERSION OF INDUSTRIAL TO RESIDENTIAL BUILDINGS

Verstraelen J., Smet F&C, Belgium, +32 14389635, jan.verstraelen@smetgroup.be
Huybrechts N., Buildwise & KU Leuven, Belgium, noel.huybrechts@buildwise.be

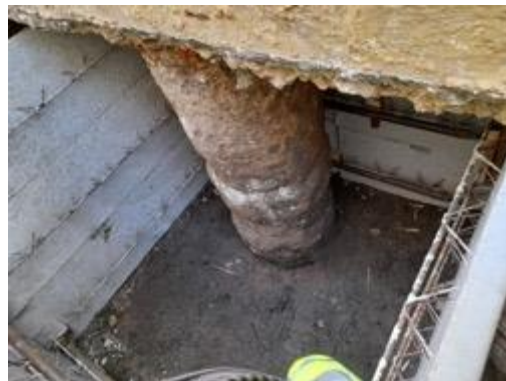
Fig. 1. Braced excavation around existing pile – Franki pile

The testing of an existing pile poses several challenges. The piles are situated underneath the existing pad foundations in an existing building and first must be made accessible. This was done by carrying out a braced manual excavation in which the foundation pad and piles (upper 1.5m) were unearthed (see Figures 1 and 2).

The information that can be obtained from these inspection pits is already very useful. Especially for the silo site, where it was discovered that the piles and their location were not accurate according to the original design drawings, with lesser piles underneath different shapes of foundations.

The inspections also allowed for the measurement of the pile diameter, which also differed from the original drawings. Regarding the pile diameter, one must be careful to extrapolate these findings, since only the top section of the pile could be measured (which can be greater than intended, especially in the softer top soil layers present here).

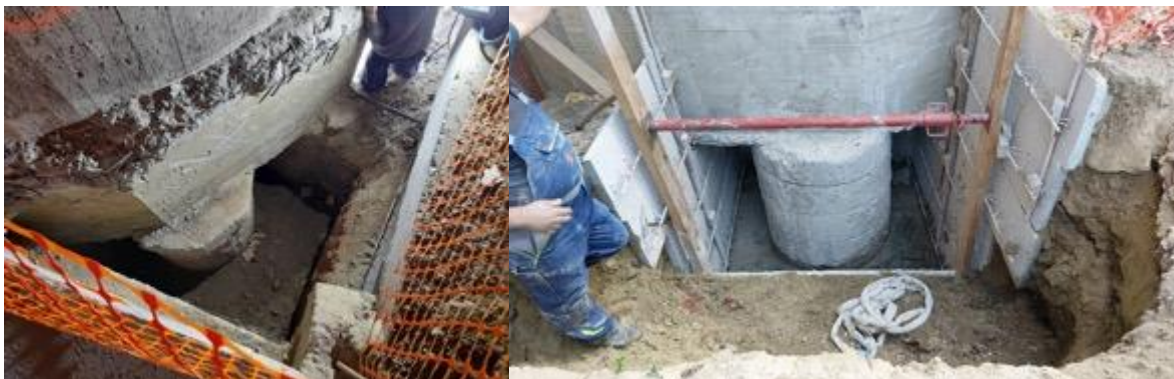
Fig. 2. Braced excavation around existing pile – bored pile

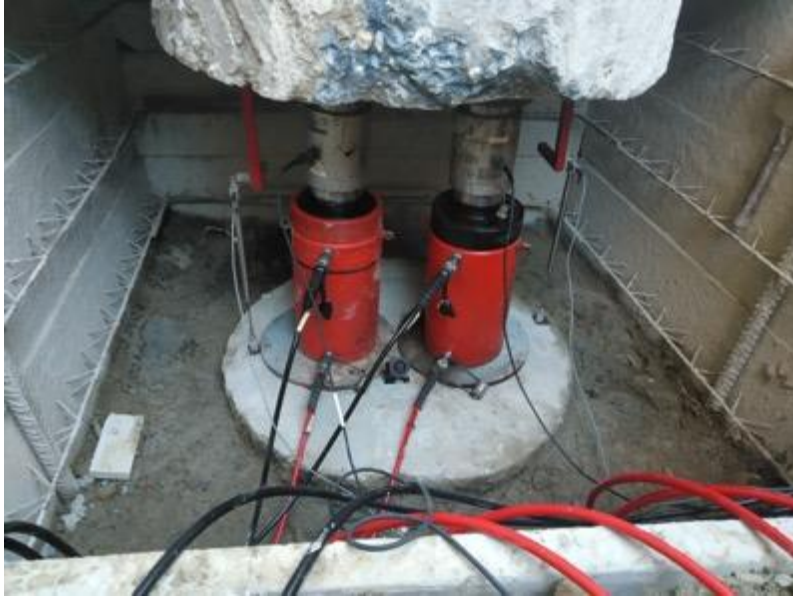
Fig. 4. Set-up for pile testing of working pile

Hydraulic jacks were placed between the existing foundation and the cut pile (see Figure 4). Displacements between the top of the pile and the foundation were measured with 2 LVDTs. Movement of the foundation itself was monitored independently through topographic measurements. This allowed not only to correct the relative pile head settlement to absolute values, but also to check the possible uplift of the existing foundation.

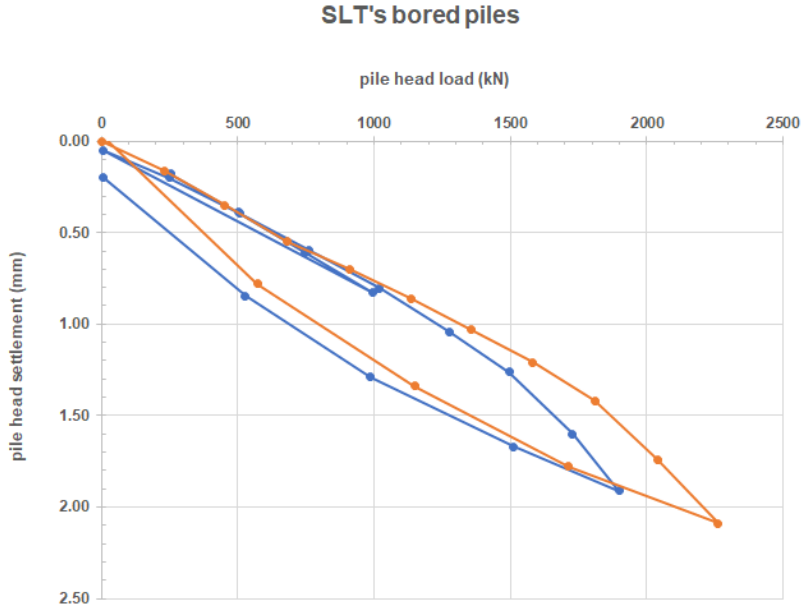
Fig. 5. Results of 2 SLTs on bored piles

Maintained load tests were performed with a constant time increment of 1h, independent of the observed creep. The results of the pile head displacement versus applied load for both bored piles are presented below. Both piles have a similar length and diameter and are installed in similar conditions.

The creep rate in both cases was negligible up to the maximum test load. When considering an ultimate pile base settlement of 10%, which corresponds to 100 mm in this case, the piles remain completely in the elastic domain and are far from their ultimate load. Total plastic deformation after unloading was smaller than 0.5 mm. Although the historic load on the piles was not known, it is believed that this load was not higher than the test load. Possibly due to this almost purely elastic pile behavior, the load deformation curve does not allow for an estimate of the maximum historic load on the piles.

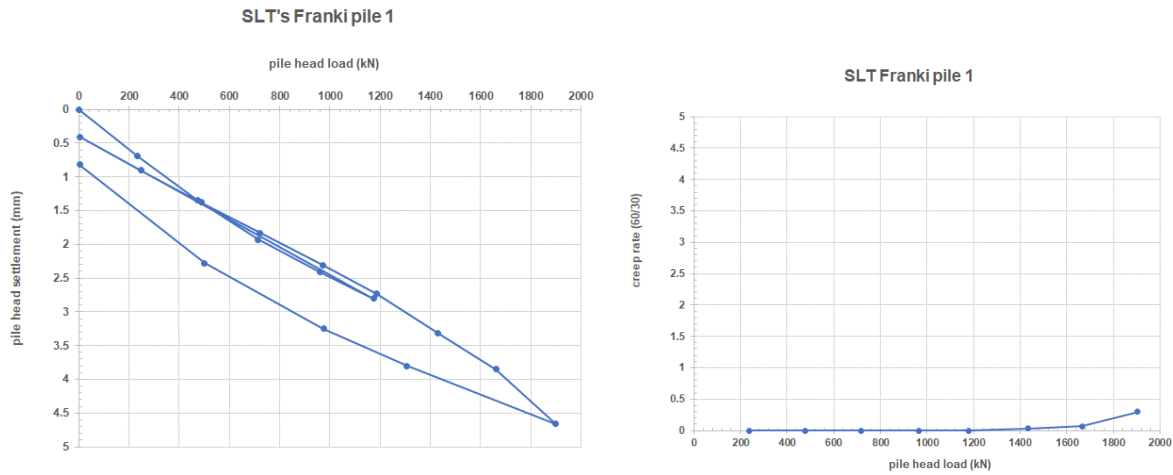
Fig. 6. Results of SLT on Franki pile (Silo)

The result of the load test on the driven c.i.s. Franki pile is presented below (see Figure 6).

Only the final load step showed a measurable creep settlement, but it is expected that the pile is still far from its ultimate load bearing capacity.

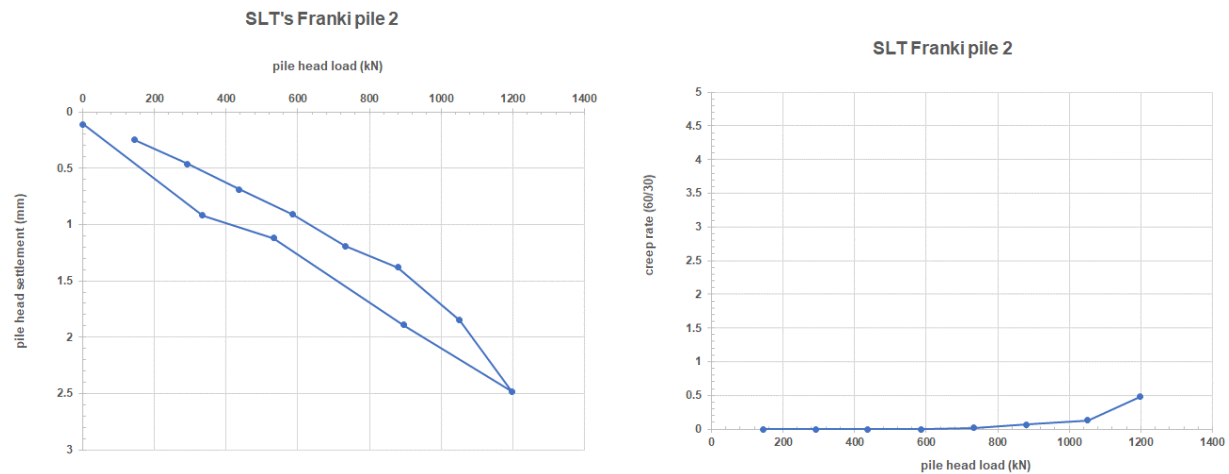
Fig. 7. Results of SLT on Franki pile (Hungaria)

The results of the load test on the second Franki pile are presented in Figure 7, and lead to very similar results, although at lower values (please note this pile was very short).
